Barbara Behrendt, Tampa Bay Times, April 12, 2013

**BROOKSVILLE** — When county officials first approved the Peck Sink stormwater improvement project in June 2011, the goal was simple: safeguarding the area's drinking water supply.

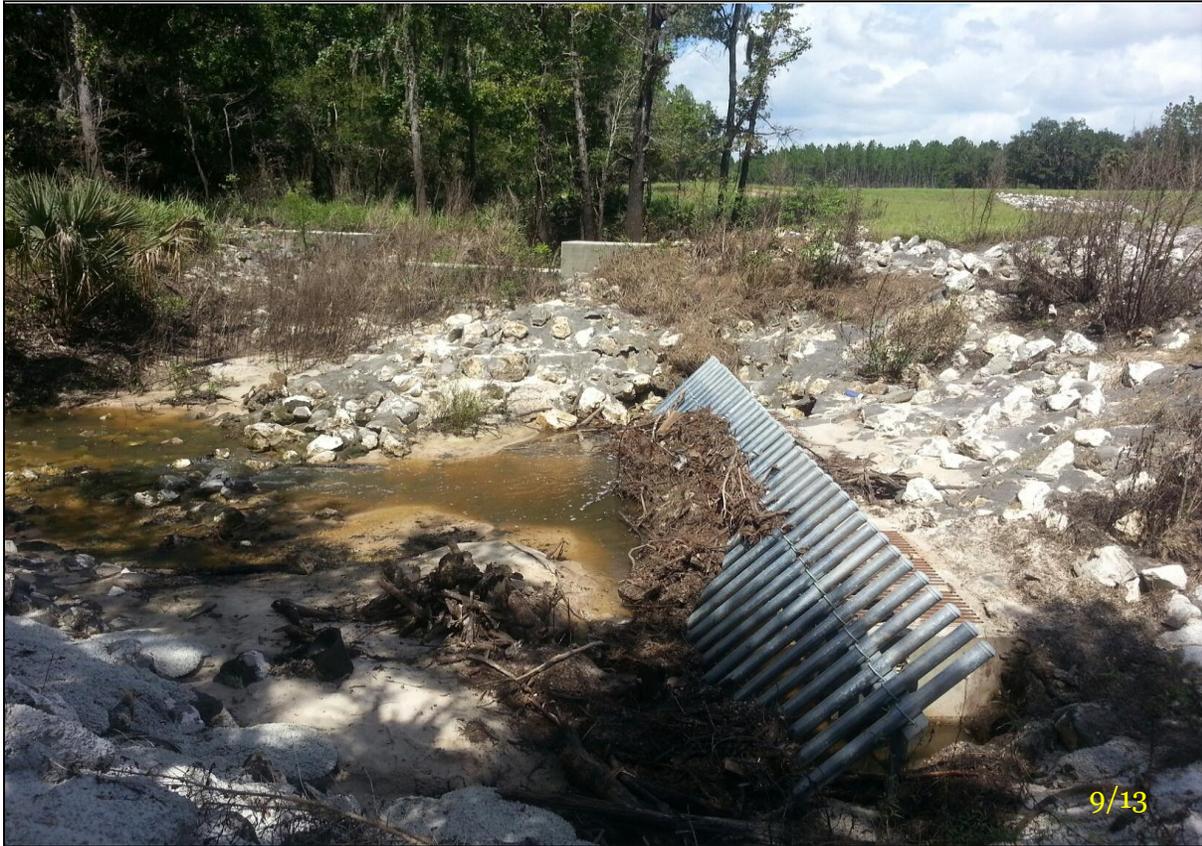
Steel grate at the entrance to settling ponds prevents large debris from entering the system

Before water even makes it to the first basin constructed on the site, it must pass over a filtering system that strains out the garbage. County employees can collect the trash and truck it away. If the water comes too fast, a nearby weir allows for an overflow back into the natural stream system. The large first pond was made stronger with sections of cascaded rocks glued together by \$18,000 worth of concrete grout. In the settling basin, other impurities can settle out before the water moves through a skimmer structure that removes oil on the surface.

Malmberg pointed out that Guttman engineered the trash filtering device, something he borrowed from a design for bar racks on a wastewater treatment plant. Velsor was proud to have been involved with the project since the start. And she is ready to take it to the next phase should the County Commission ever change its mind about development of a passive park once planned for the property next door.

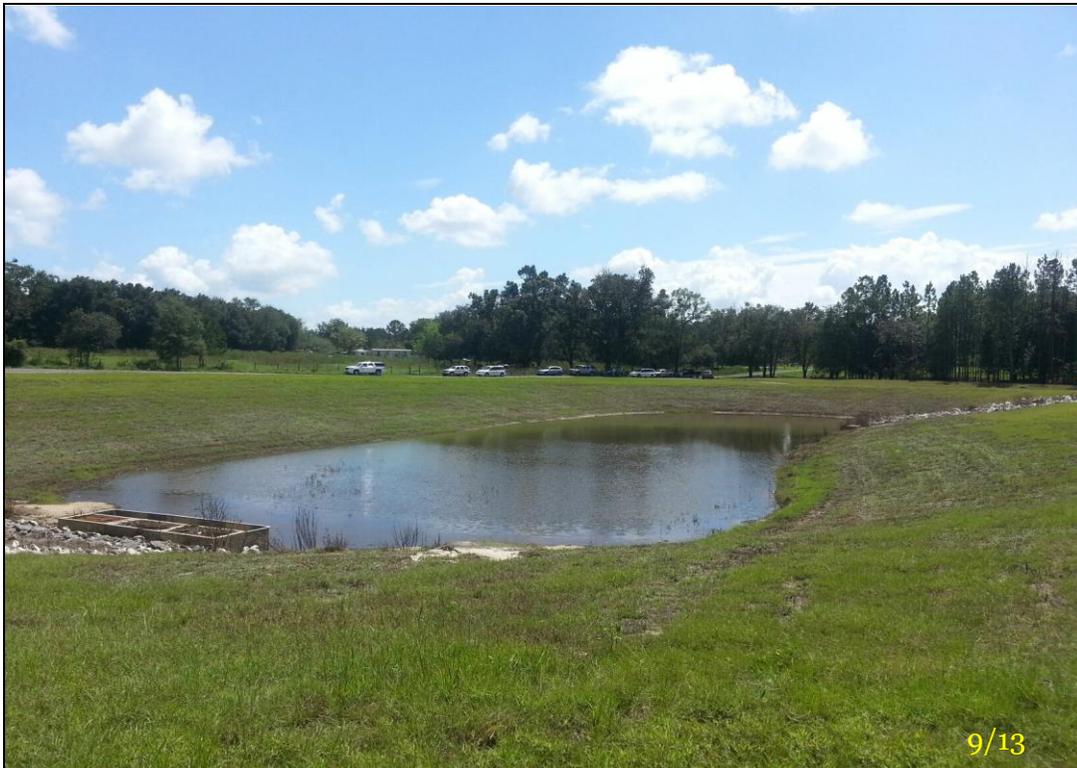
First settling pond. View is looking south towards Wiscon Road

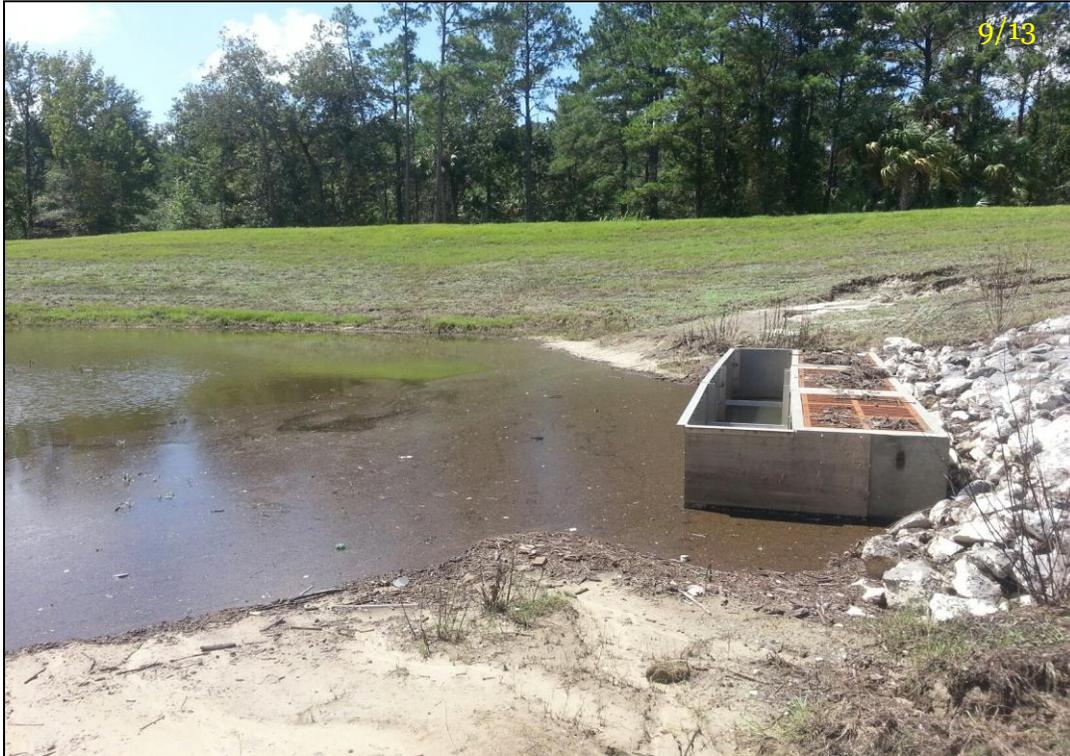
First settling pond showing “skimmer structure” that minimizes the carry-over of contaminants into the next settling pond

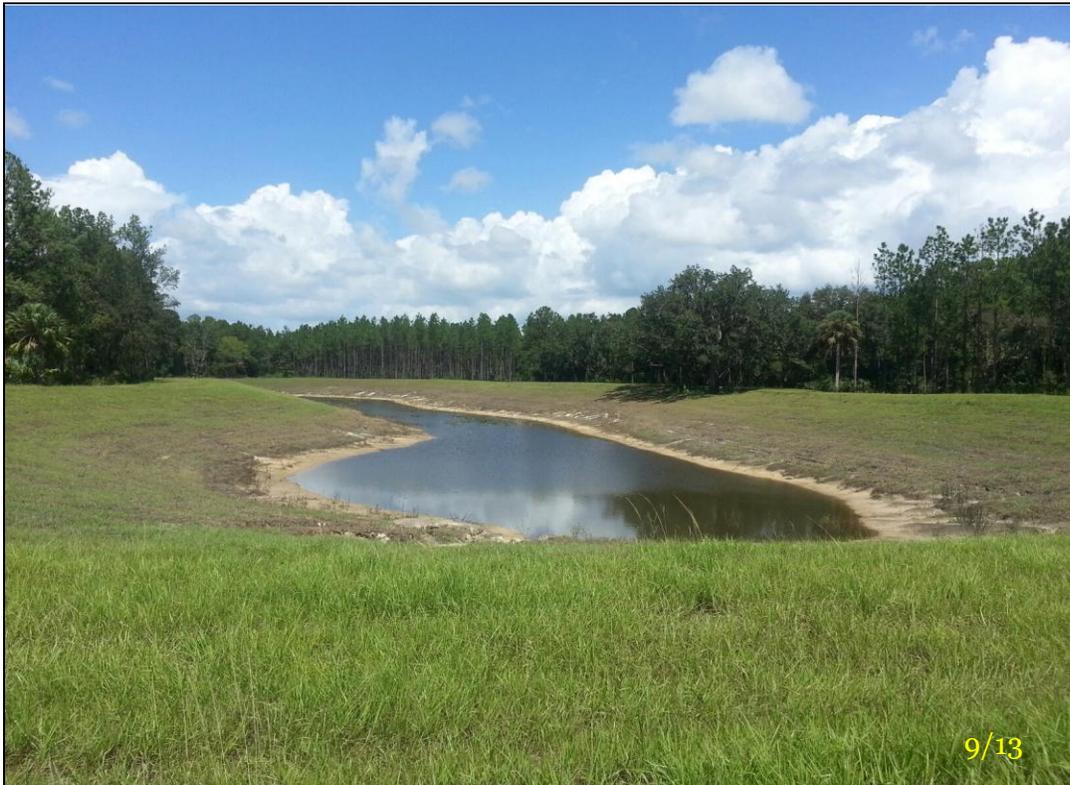
Second settling pond, view is looking north

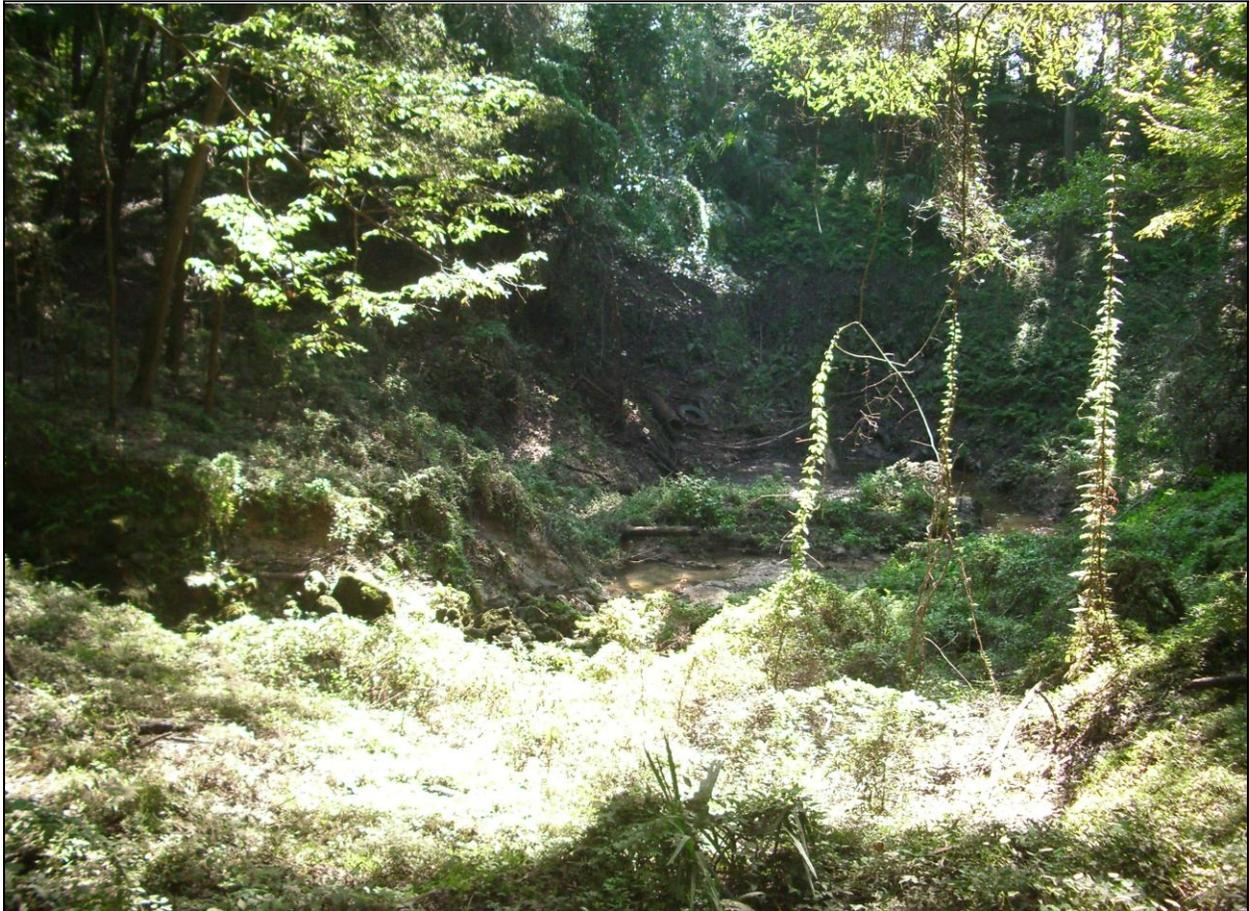
Peck Sink is a large depression in the ground where stormwater collects, and drains directly into the aquifer. This is where we get our drinking water from. Therefore, it's understandable why it is so important to prevent contaminants from entering the water system. Note the auto tire on the far side of the sink.
